**Flood Control Project Maintenance
Levee Inspections**

Fall 2011 Levee Maintenance Deficiency Summary Report

Reclamation District No. 1601 Twitchell

Waterway			Bank	Unit Miles
Unit No. 01 Threemile Slough			Left	2.47

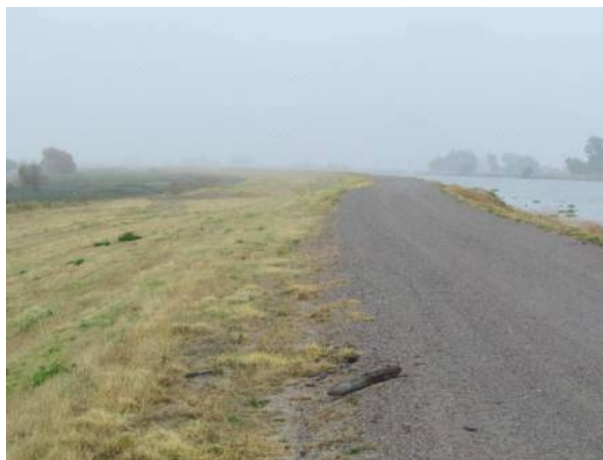
Levee Mile Report Line	1
Start Levee Mile	0.00
End Levee Mile	2.47
Location	Land Side
Category	Earthen Levee
Item	Vegetation

Looking south at typical view of levee

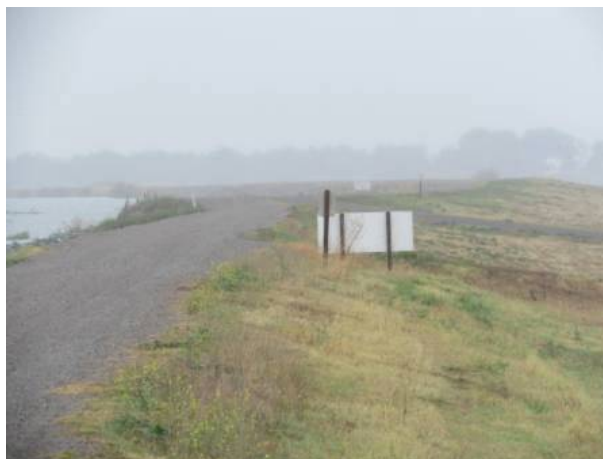
Levee Mile Report Line	1
Start Levee Mile	0.00
End Levee Mile	2.47
Location	Land Side
Category	Earthen Levee
Item	Vegetation

Looking north at typical view of levee.

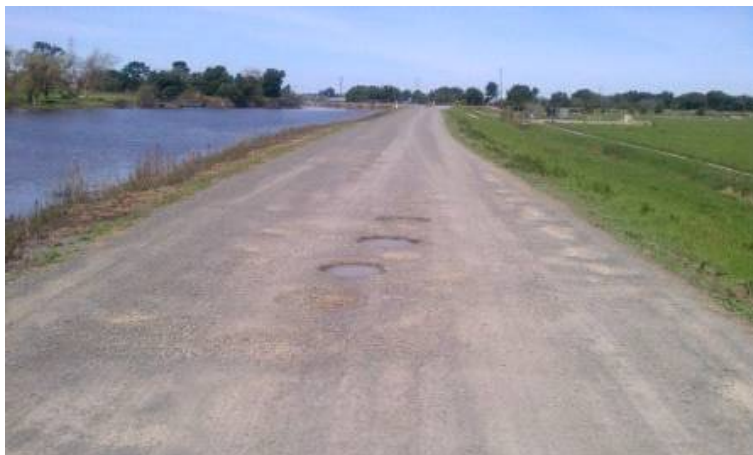
Levee Mile Report Line	2
Start Levee Mile	0.10
End Levee Mile	1.31
Location	Crown
Category	Earthen Levee
Item	Crown Surface / Depressions / Rutting

Looking north at holes on levee crown.

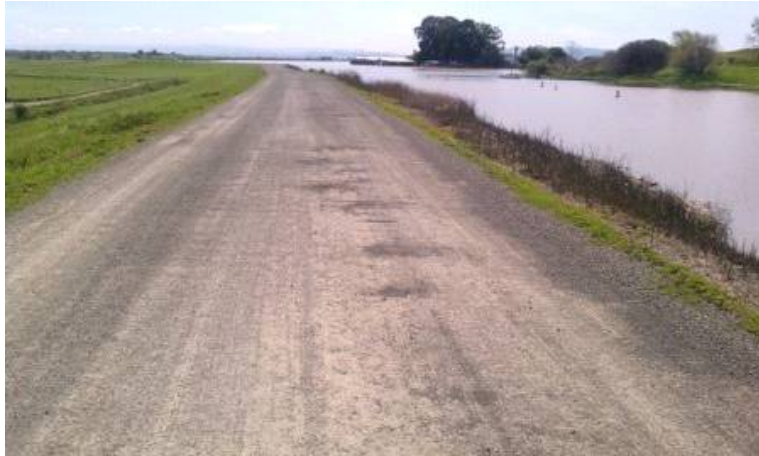
Levee Mile Report Line	2
Start Levee Mile	0.10
End Levee Mile	1.31
Location	Crown
Category	Earthen Levee
Item	Crown Surface / Depressions / Rutting
Looking south at crown surface rutting.	
richard_f_20110922_554.jpg
